CARLO GAVAZZI SPACE SpA		0 CERN MIT L3 A&C/AMS AMS02-PDS			1 Doc.N°: NCR-PDS-CGS-C-128 Rev.: 1 Date: 18/12/2008 Page 1 of 2 attach: A,B,C,D,E	
		NON CONFORMANCE REPORT				
2 NCR Title: CAN BUS 01/02 CPU_RST command						
IDENTIFICATION	3 Supplier	4 Purchase Order N°	5 Model	6 Subsystem	7 Procedure/Work Item N°	
	CGS	N.A.	PFM	N.A.	N.A.	
	8 NC ITEM Identification	9 Drawing N°	10 Rev.	11 P.N. / C.I. N°	12 Serial N°	
	Can Bus I/F Board Assy	11-AMS02PDS-500.00	/	11-AMS02PDS-500.00	01 / 02	
	12 Next Higher Unit Id.	13 Drawing N°	14 Rev.	15 P.N. / C.I. N°	16 Serial N°	
	AMS02 Power Distribution System Assembly	10-AMS02PDS-000.00	/	10-AMS02 PDS - 000.00 POS 18	FM01	
DESCRIPTION	18 NON CONFORMANCE Detected During:					
	RECEIVING INSP. <input type="checkbox"/> MANUFACT. <input type="checkbox"/> ASSEMBLY/INTEGRATION <input type="checkbox"/> FINAL INSPECTION <input type="checkbox"/> TEST <input checked="" type="checkbox"/> OTHER <input type="checkbox"/>

NON CONFORMANCE REPORT

Doc.N° : NCR-PDS-CGS-C-128

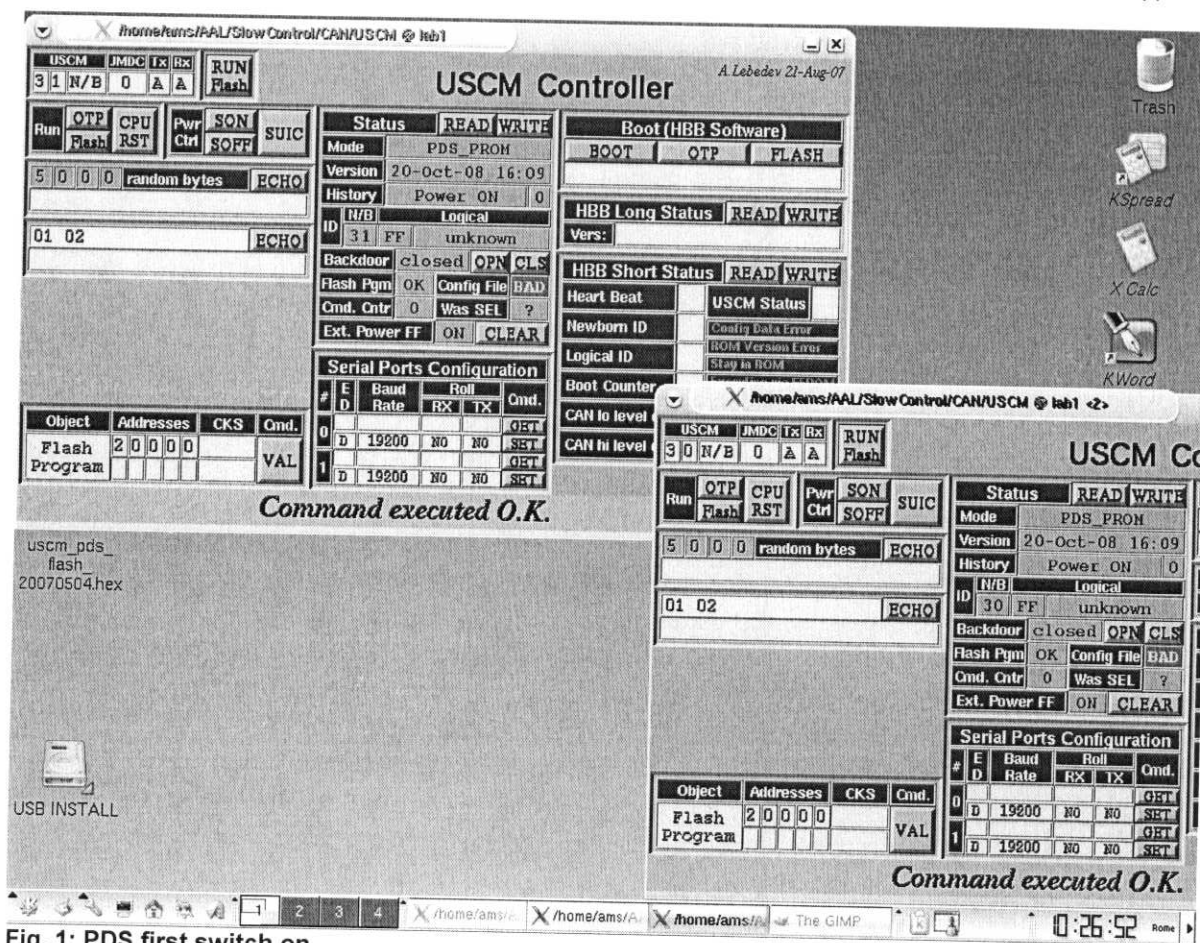
Fig 1 shows the result: as expected the boards starts in prom and history shows Power ON (first startup).

Fig. 1: PDS first switch on

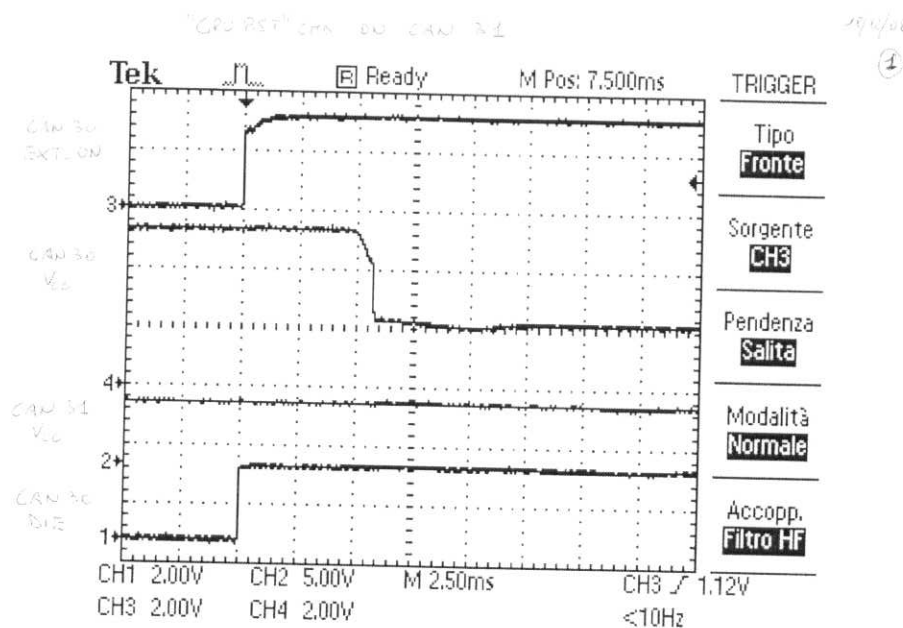
Pressing the button "CPU_RST" the CAN 31 micro set the pin S_ON and the pin S_OFF (connected to relative circuit on Can 30) to high value at the same time. This correspond to found the can 30 board SWITCHED OFF.

Fig 2 shows the rising of the command lines and fig.3 shows the sw reading. After this command the CAN 31 remain in the previous condition while the CAN 30 results in OFF status.

Fig. 2: CAN 30 input lines during "CPU_RST" command on can 31.

New sw has been loaded and tested on both CAN BUS FM board S/N 01 and 02 successfully.
Pressing the CPU RST button on the software test the anomaly has not been reproduced anymore.
The lines S_ON and S_OFF are not commanded in high state.
The CPU RST button issue is considered solved.

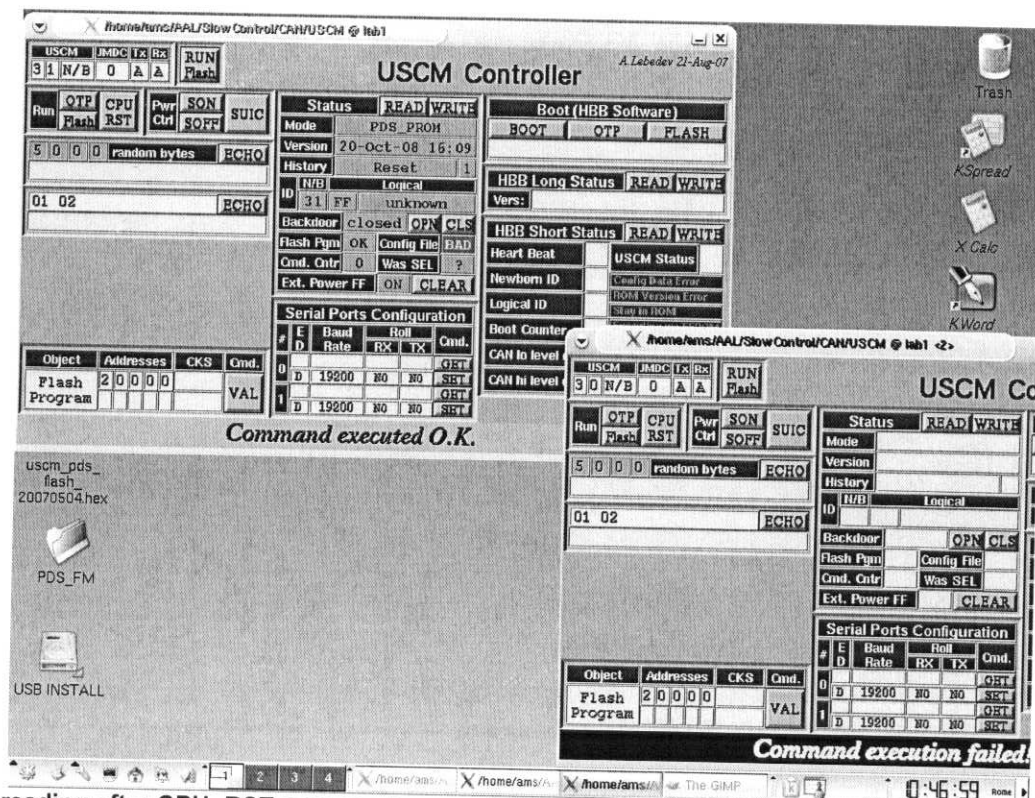
Fig. 3: reading after CPU_RST command on can 31

At this point the lines S_ON and S_OFF of can 31, corresponding to EXT_ON and DIE on can 30, remains in high value state for an indefinite time.

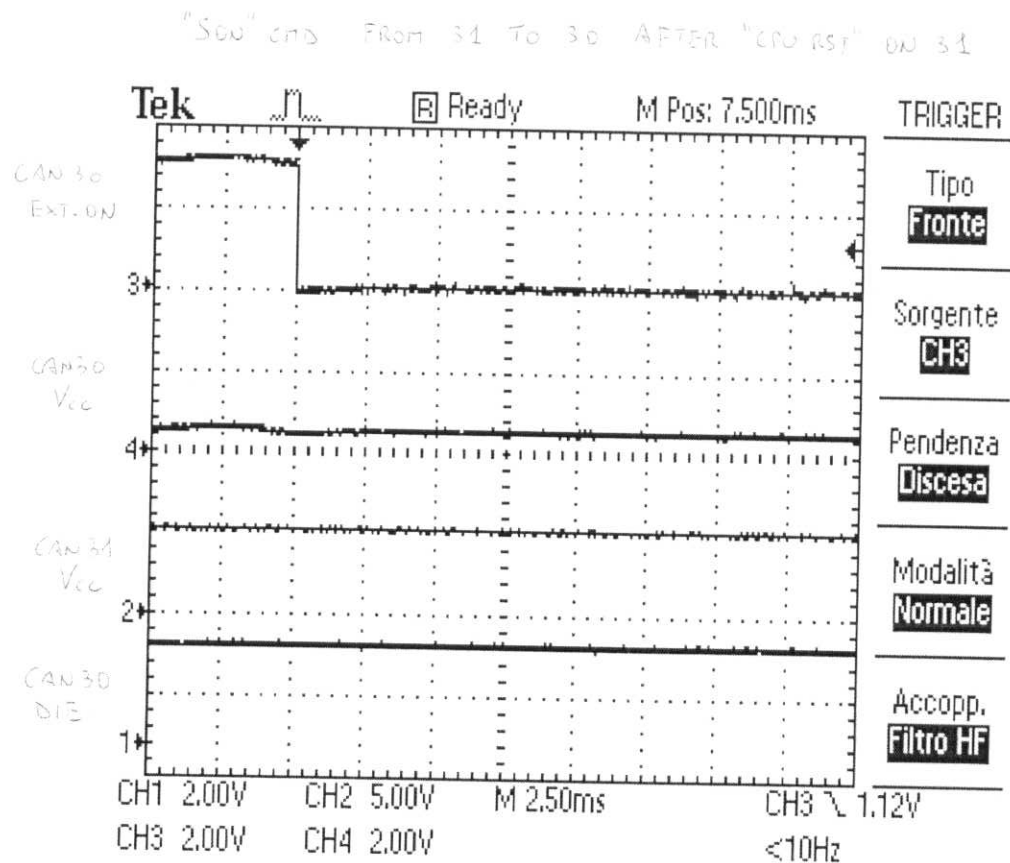
Sending the S_ON the can 30 remains in OFF condition. The micro output line is now reset and come back to correct ZERO value as fig.4 shows.

Fig. 4: S_ON command from 31 to 30 after "CPURST" command

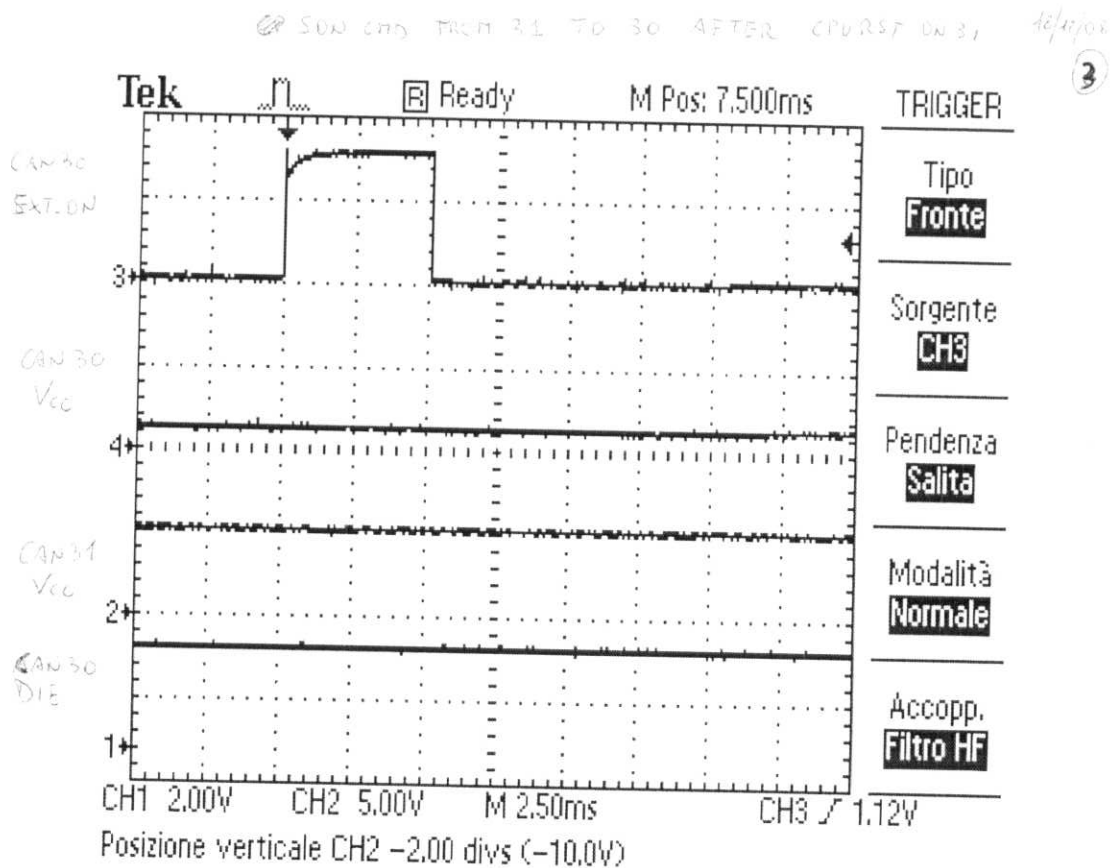
A second S_ON command has been sent to verify if can 30 comes back alive. But due to the presence of the high state of the DIE line the board does not restart. Fig.5 shows this situation.

Fig. 5: S_ON command from 31 to 30 second try

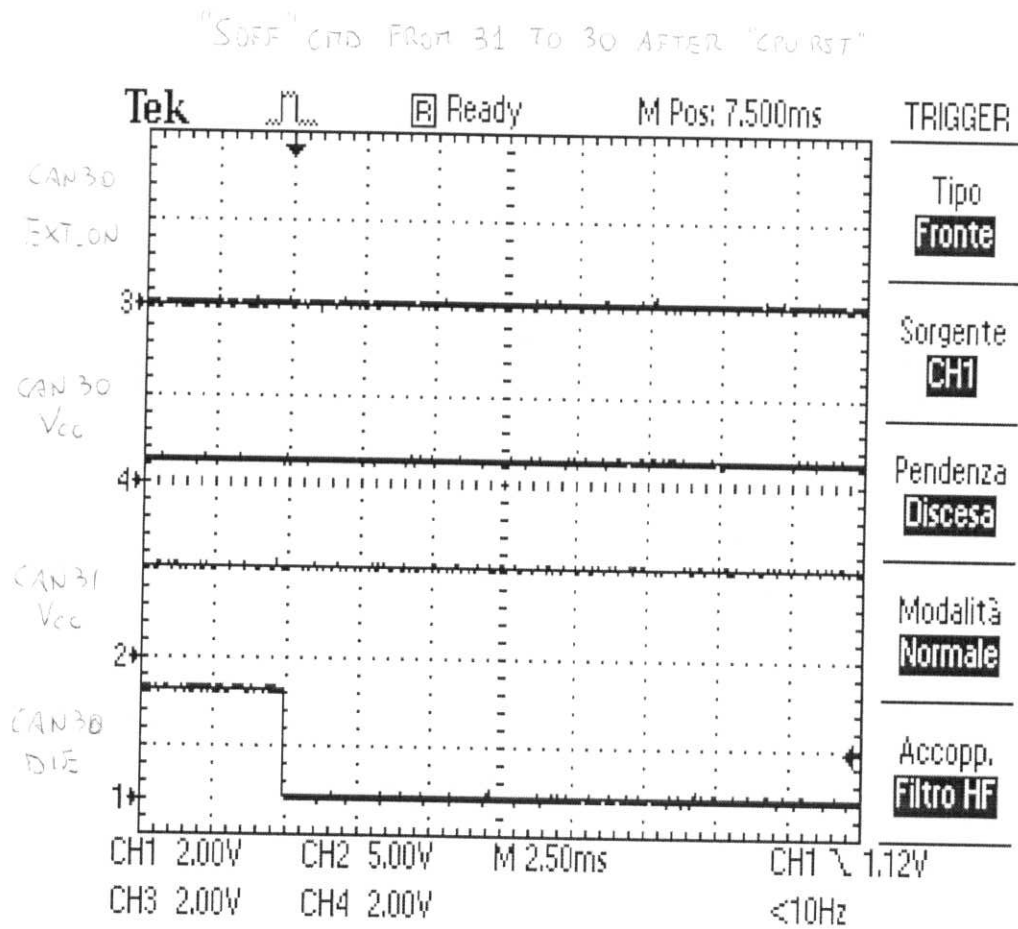
The S_OFF command has been sent to reset the die line on can 30. fig.6 shows the line transition.

Fig. 6: S_OFF command from 31 to 30.

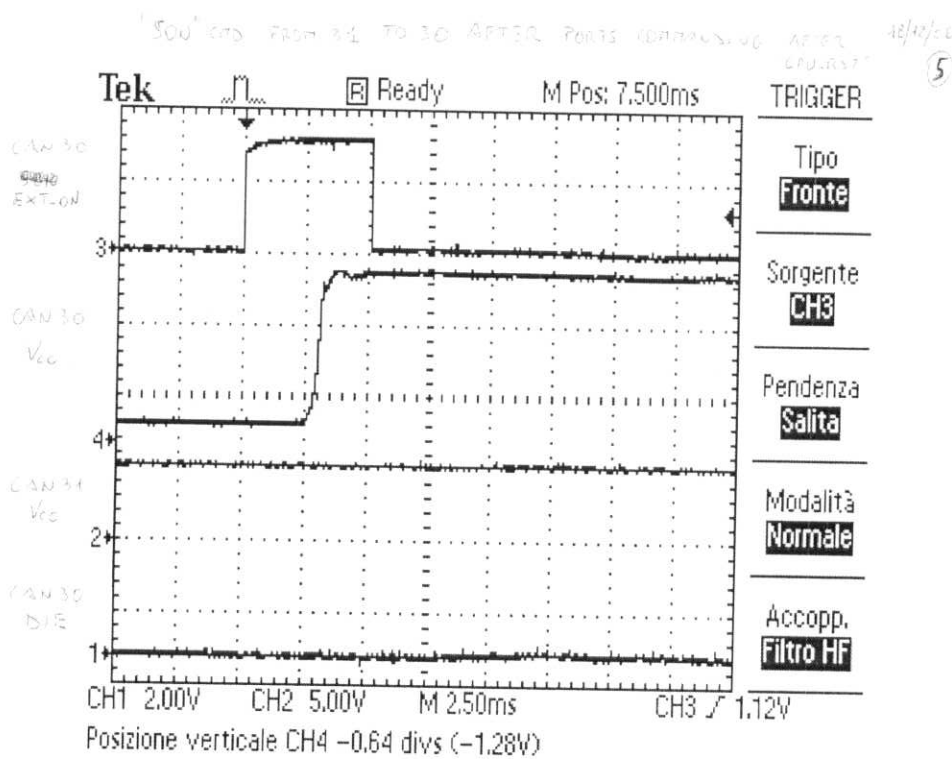
At this point an S_ON command has been sent again to verify if can 30 comes back alive. At this time the board restarts. Fig. 7 shows line transitions while fig.8 show the sw reading.

Fig. 7: S_ON command from 31 to 30 after resetting the command lines.

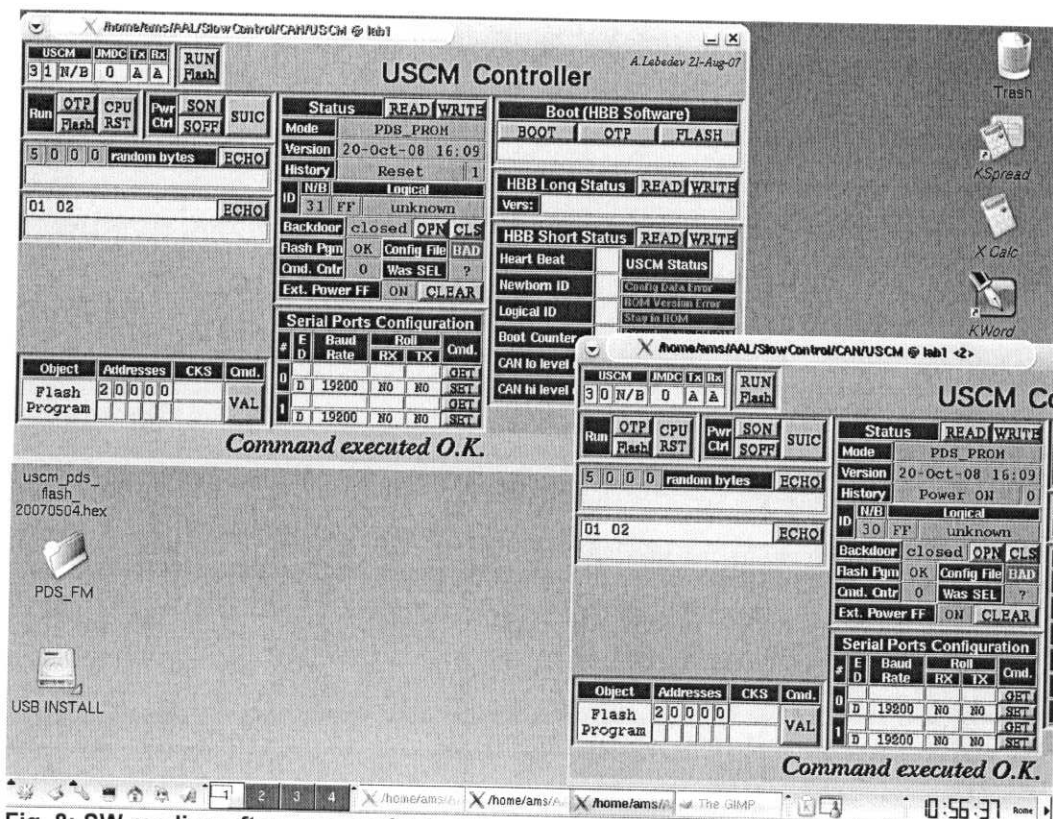
Fig. 8: SW reading after successful S_ON command from 31 to 30.
